# Essays on Nuclear Energy & Radioactive Waste Management

## **Further Analyses of the Unburied Goiania Accident Packages<sup>6</sup>**

**Abstract:** In 1987, in the city of Goiania, Brazil, a derelict teletherapy machine was disassembled by scavengers and Cs-137 was released in the environment, unleashing the biggest radiological accident in Brazil. During the 15 days before the accident was acknowledged, some contaminated materials were sold and delivered to recycling factories in a few cities in the state of Sao Paulo, Brazil, in the form of metal scrap and recycled paper bales. The contaminated material was then collected, the metal scrap was conditioned in forty-three 200-liter drums, and the paper bales were stored in fifty 1.6 cubic meter steel boxes at the interim storage of the Nuclear and Energy Research Institute (IPEN), in the city of Sao Paulo, and there remained ever since. In 2017, 30 years later, initial analyses were performed at a sample of these boxes, checking for their activity, weight, and incongruences between the original values recorded at the time of collection and the measurement results 30 years later. The results indicated that none of the boxes check

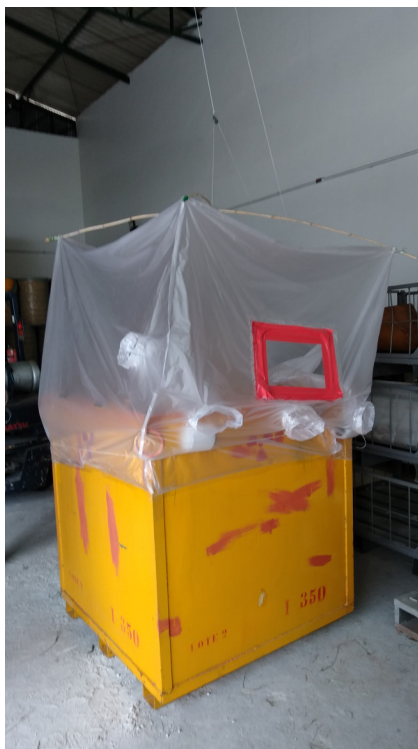
**Figure 1** - Plastic cap over the waste box.

The cover allows samples to be taken from the box without the risk of contamination of the air or surrounding surfaces. Gloves were installed on the front and lateral sides of the cover to allow unscrew the bolts and lift the lid. An acrylic plate was added to the front of the cover for better visual inspection. Such actions aimed at ensuring the environment was kept clean and safe.

The objective of this research is to perform visual inspection of the waste inside the boxes, and to collect samples for laboratory analyses. Considering that no large enough cell with air containment is available and in order to avoid possible air contamination when opening the boxes, due to potential spreading of radioactive dust or microorganisms, a plastic cover that would serve as a containment (Figure 1) was assembled over the box.

The unexpected presence of a high moisture content inside the waste boxes had two consequences: the first and immediate one was that the opening of the boxes did not require a containment to prevent air contamination by spreading of radioactive dust or microorganisms. Because of that, the containment hood was not used in the next two boxes that were opened.

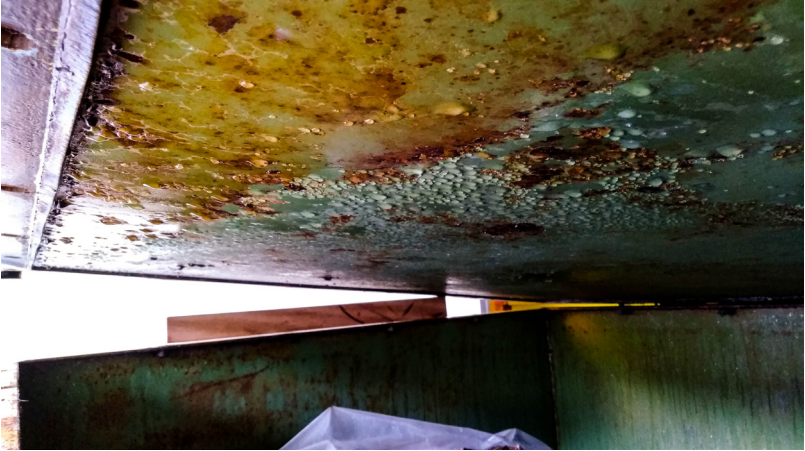
After opening three boxes, the presence of high moisture content was observed (Figure 2), as well as a marked reduction in paper volume of the order of 10 to 30% (Figure 3).

**Figure 2** - Inside of the box that showed the highest moisture content. Note the water droplets formed by condensation in the underside of the box lid.

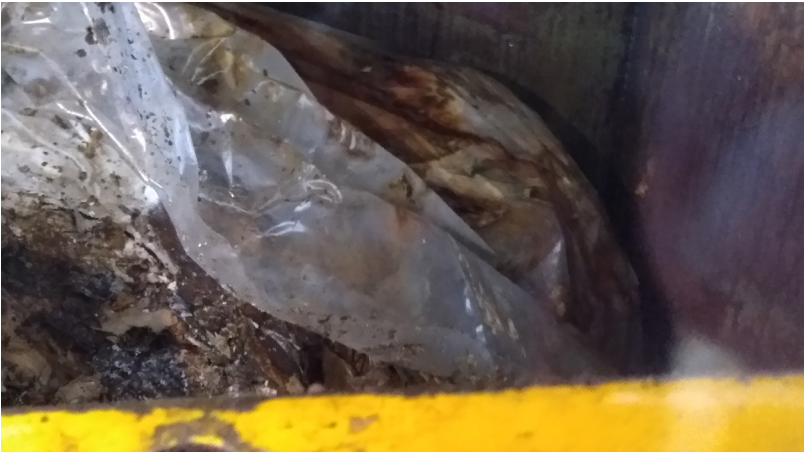
**Figure 3** - The paper bale collapsed, reducing the volume by about 30% of the original height. By the touch, the mass appears like moist clay.

In 1988, the paper bales were filled up to the limit of the capacity of the boxes, as seen in page 45. Therefore, the volume reduction is associated with the moisture build up, which could only be explained by microbial action.

The paper bales, originally tied and wrapped in a plastic bag, have fallen apart and the paper degraded up to the point that the cellulose fibers appear broken in the examination under the microscope. The paper in all samples appeared as small fragments, visibly degraded [5], with colors varying from light brown to dark brown or black. In some parts of the box with the highest moisture content, it looked like a soft, wet mass, like moist clay.

The second consequence was that the original idea of using physical-chemical methods to treat the waste and reduce its volume was abandoned in exchange of a method using microorganisms which attack the complex lignin molecule, as paper may contain up to 20% of lignin [6]. The microbial action on the paper bales proved to be equally effective in reducing the volume of this waste and, in addition, has the advantage of being less aggressive to the metallic boxes.
