STUDY OF MECHANICAL AND CHEMICAL PROPERTIES STABILITY OF INNER TUBES EXPOSED TO GAMMA RADIATION

Sandra R. Scagliusi^{1*}, Elizabeth L.C. Cardoso², Fabio J. Esper¹, Ademar B. Lugão²,
Helio Wiebeck¹

1 – Department of Materials Engineering, University of São Paulo (USP), São Paulo, SP, Brazil.

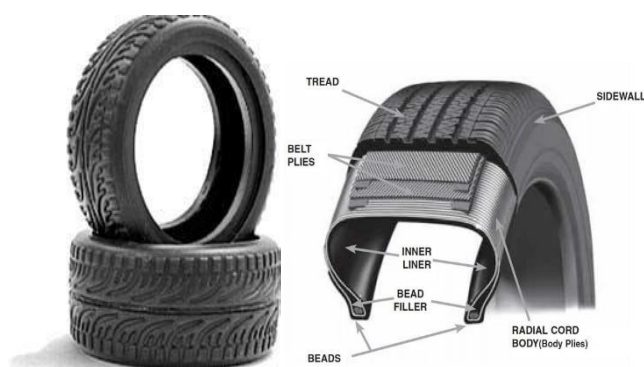
Figure 1. Typical passenger tire and components of a run flat tire [6]

in separate and to joint all parts the companies use presses and mills [5]. In Fig. 1 it is shown the components of a car tire.

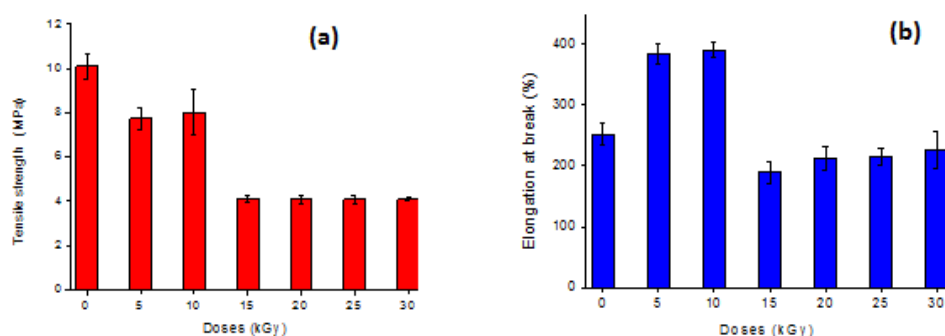
Figure 3. Tensile Strength for irradiated and non-irradiated truck chamber (a) and Elongation at break for irradiated and non-irradiated truck chamber(b).

Results for tensile and elongation at break analyses of irradiated and non-irradiated truck chamber samples are shown in Fig. 3 (a) for Tensile and in Fig. 3 (b) for Elongation.

It is observed that values for tensile at break show a more sharp decrease in values for doses higher than 15 kGy, pointing to a raise in chain-scission caused by irradiation. For doses higher than 15 kGy, there is an equity in values suggesting a competition between scission and crosslinking.

For elongation at break results it is noted a raise in values for doses up to 10 kGy, suggesting the occurrence of crosslinking; for doses higher than 15 kGy there is a decrease in values, indicating a raise in chain-scission, because lower chains present lower elongation.

Tensile and elongation at break mechanical tests showed for irradiated samples values decreasing in function of a raise in dose, suggesting the occurrence of chain-scission, because smaller chains present smaller elongation and suffer rupture easily.

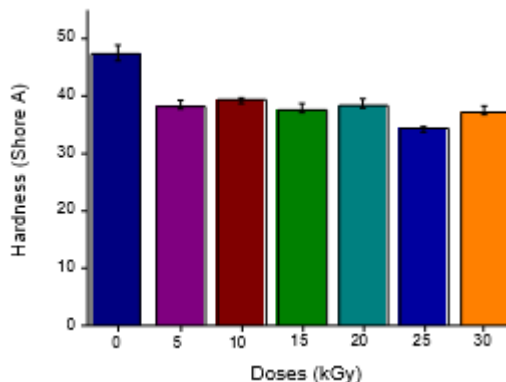
Figure 4. Hardness of non-irradiated and irradiated truck chambers.

Hardness results are characteristic of rigidity presented for a rubber compound. Hardness results for irradiated and non-irradiated truck chamber samples are shown in Fig. 4.

After irradiation, samples showed a lower decrease in values; nevertheless, with a raise in dose, it was verified an equity of values for all doses. According to expected, hardness is reduced after mechanical shearing; this is explained based in degradation mechanism that leads to a de-polymerization, i.e., the weakening of elastomer matrix imparted by chain-scission and/or a raise in crosslinks.

Hardness result, that indicates material rigidity, presented lower values after irradiation; this is probably caused by degradation mechanism that leads to a de-polymerization, i.e., weakening of elastomeric matrix caused by chain-scission and / or a raise in crosslinking.
